Metro Property Inspection Report

14356 Anystreet Lane Overland Park, KS 66209

Inspection Date:
8/24/2009

Report Number:
123456789

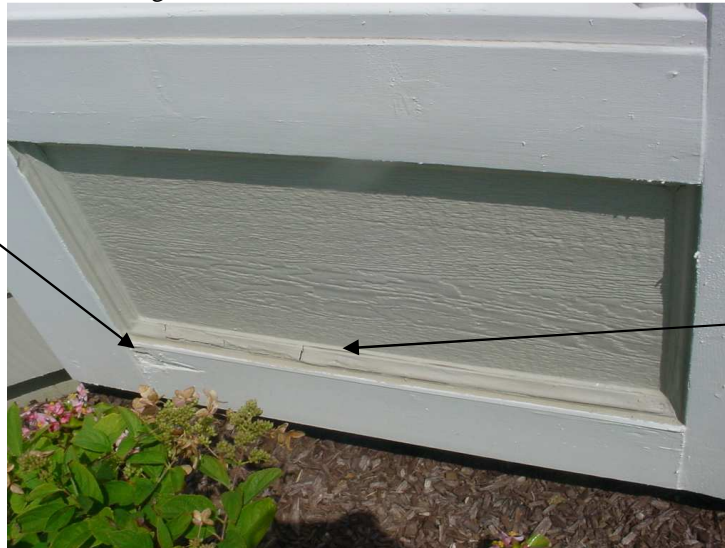
- **Repair:** Localized rot was observed in the siding at the rear wall. Following repair of the damaged areas (which should be combined with exterior painting/maintenance) proper maintenance of the siding and control of water from roof or surface runoff can avoid further damage.

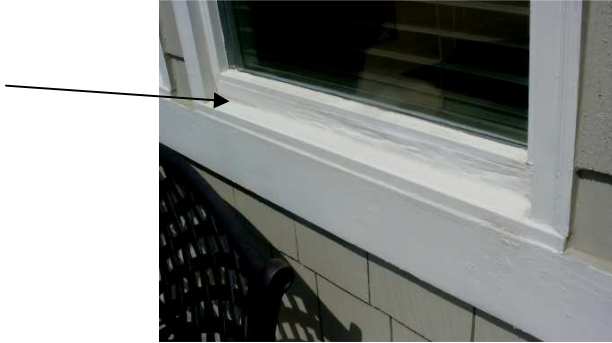
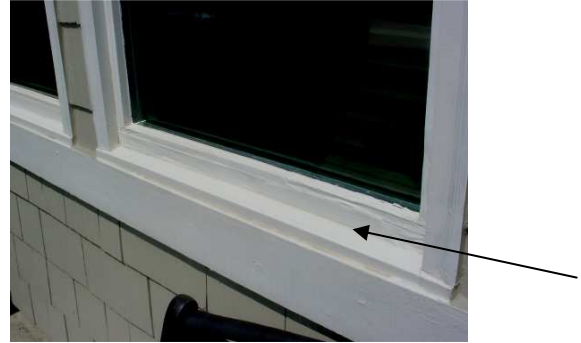
- **Repair:** Localized evidence of rot was visible at window sills at the rear wall. Repairs should be undertaken in the near future to prevent any moisture from entering the wall cavity or living spaces.

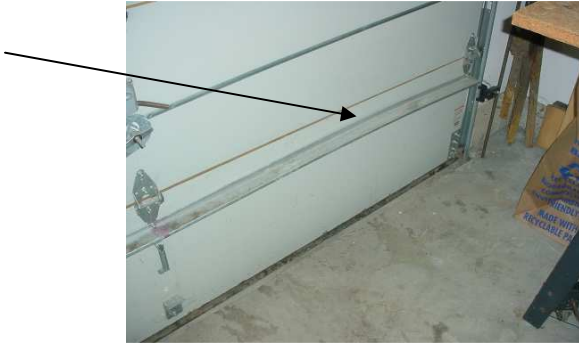
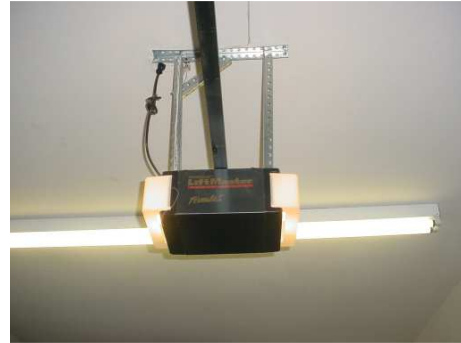
- **Repair, Safety Issue:** The smaller garage door opener did not automatically reverse under resistance to closing. ***There is a serious risk of injury, particularly to children, under this condition.*** The opener is in need of adjustment. This is likely how the damage to the rear of the door occurred.

- **Repair:** The smaller overhead garage door is damaged repairs can be made on a discretionary basis.
- **Repair, Safety Issue:** The smaller garage door opener did not automatically reverse under resistance to closing. ***There is a serious risk of injury, particularly to children, under this condition.*** The opener is in need of adjustment. This is likely how the damage to the rear of the door occurred.

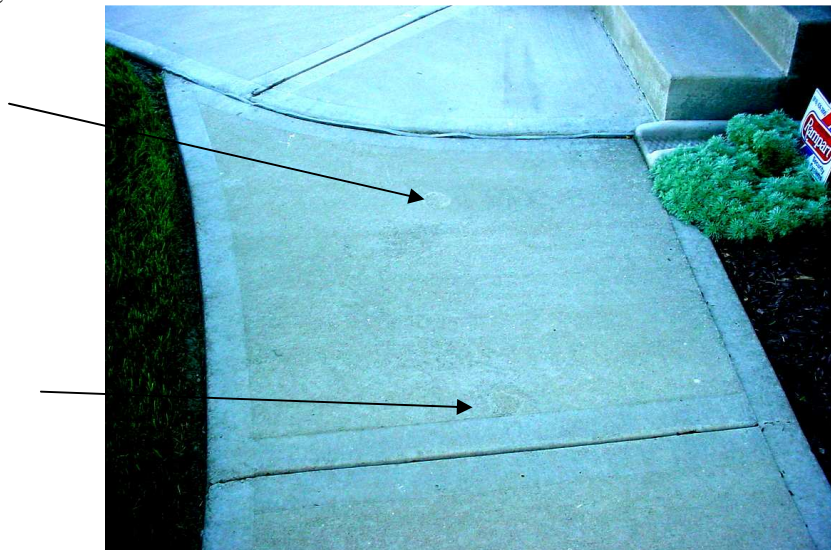
- **Monitor:** The soil below the walkway (on the side of the home) has settled in the past and the pad near the driveway has been mudjacked. This area should be monitored for any future movement. Persisting movement may result in the need for resurfacing.

Arrows are indicating the location of the mud jacking concrete repairs.

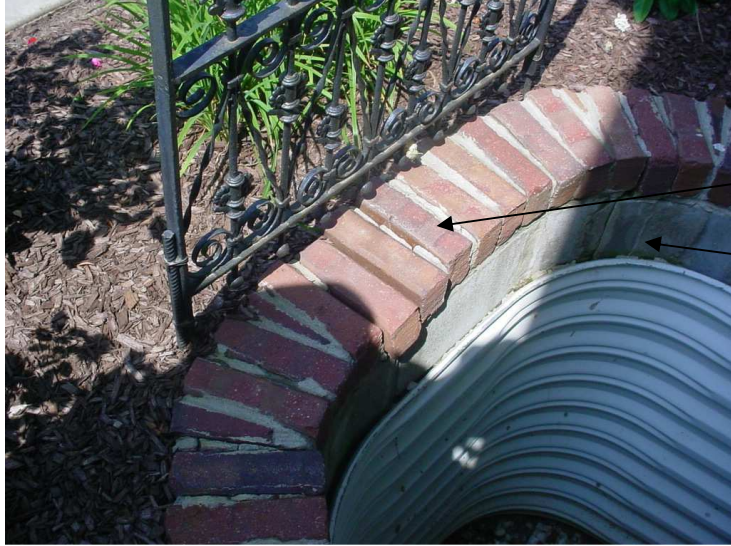
- **Repair:** The retaining wall around the basement egress window should be rebuilt.
- **Improve:** This window well must have a ladder installed in order to qualify as a method of egress.

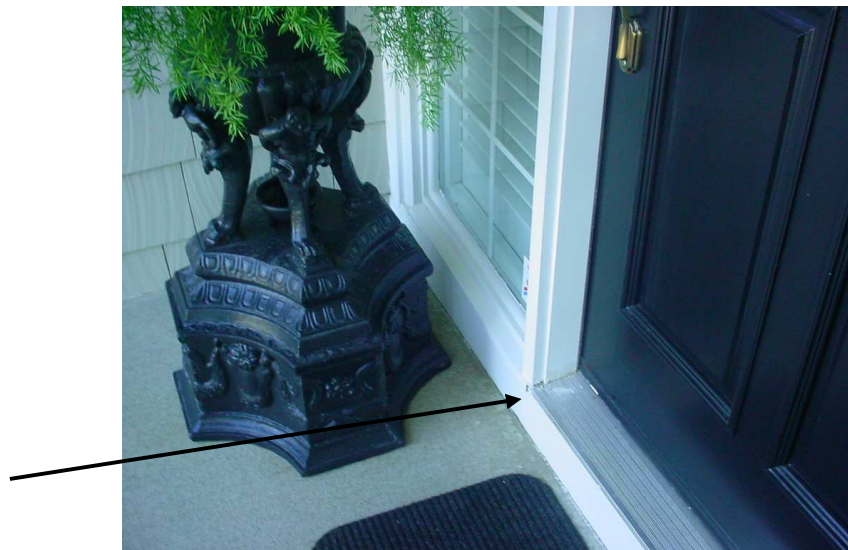
- **Repair:** The front door appears to have been damaged (the bottom sill/threshold is not allowing the door to be plumb with the exterior of the home when shut. We recommend evaluation and repairs as necessary by a qualified door/window contractor.

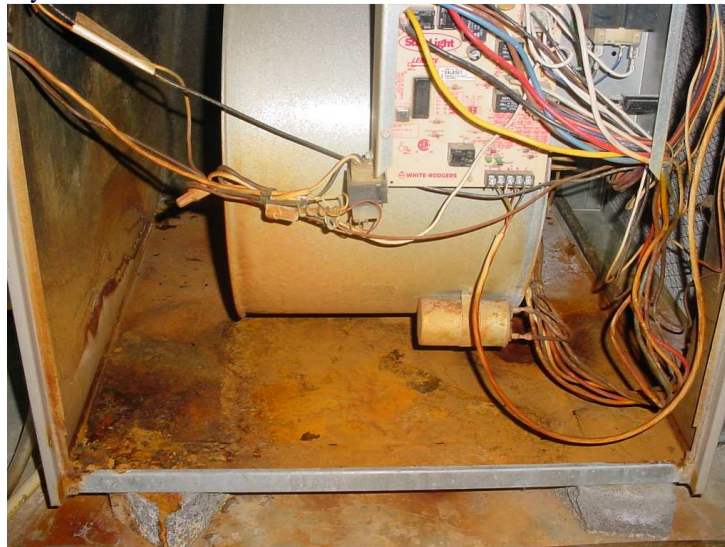
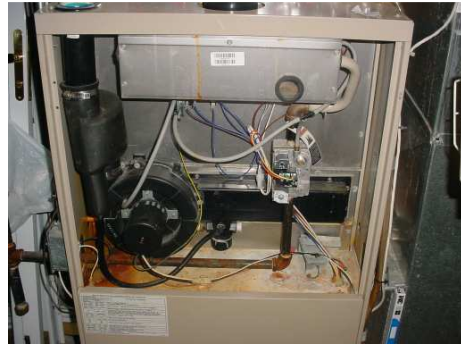
1st Floor Unit

- **Repair:** The heating system for the first floor and basement requires service. There is a very large buildup of rust in the blower section of the unit. Due to the amount of damage present we recommend evaluation and repairs as necessary by a qualified HVAC technician. It should be noted that the unit did operate properly at the time of inspection however overall life expectancy may be reduced based on the units current condition.

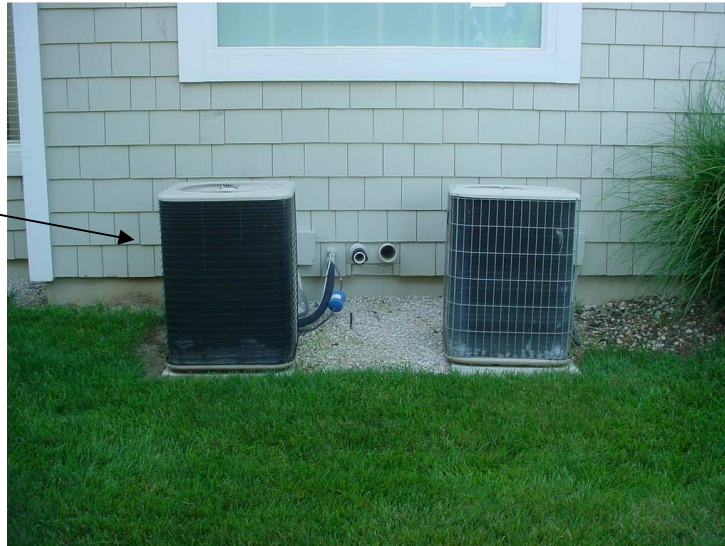
The arrow is indicating the newer of the two units

The A/C system was able to generate a 19 degree temperature drop at the registers on both the first and second floors. This result is indicative of a properly operating system.

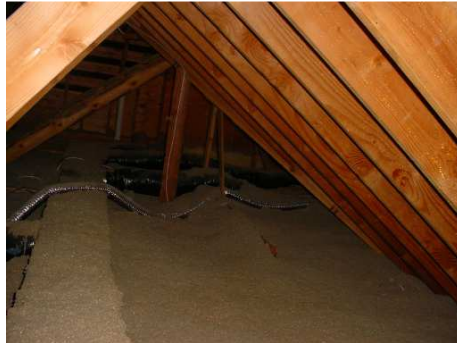
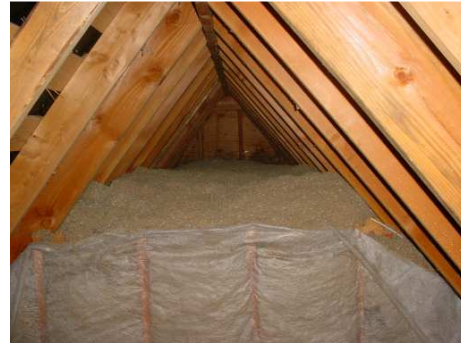
See the combination of both blown in loose cellulose and batt type fiberglass insulation in vaulted areas.

The amount and distribution of insulation in the attic should provide adequate thermal protection to the living spaces.

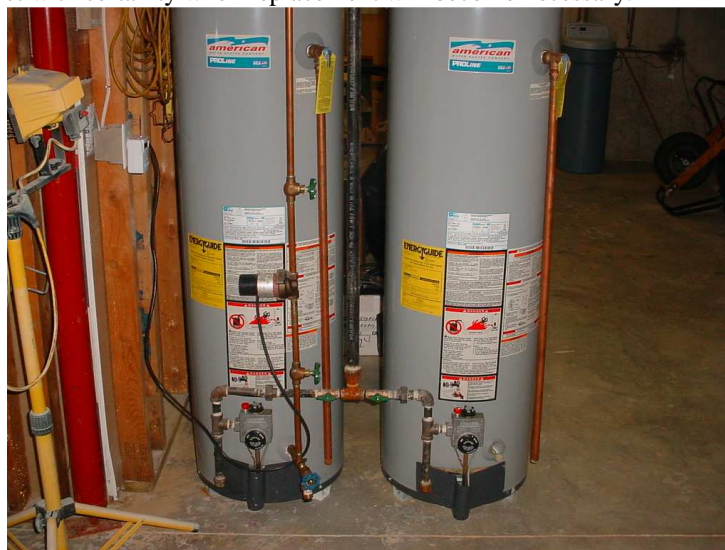
- **Monitor:** Water heaters have a typical life expectancy of 7 to 12 years. The existing units are approaching this age range. One cannot predict with certainty when replacement will become necessary.

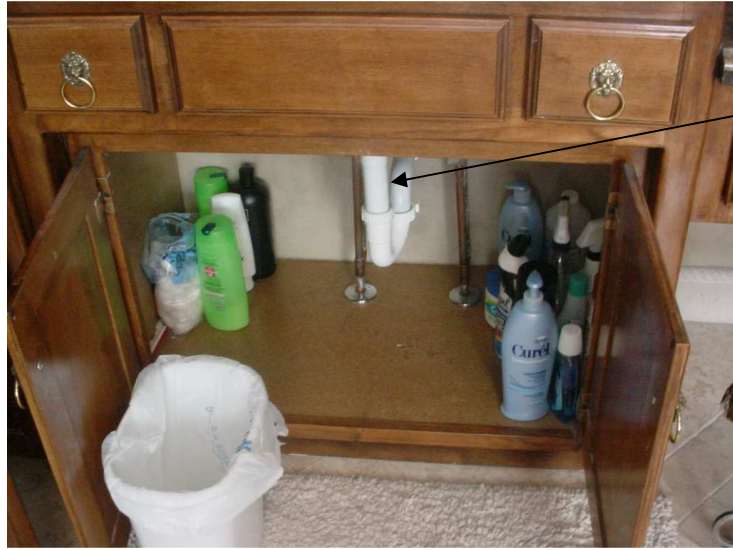
- **Repair:** The trap in the master bathroom is leaking. Repairs are recommended at this time.

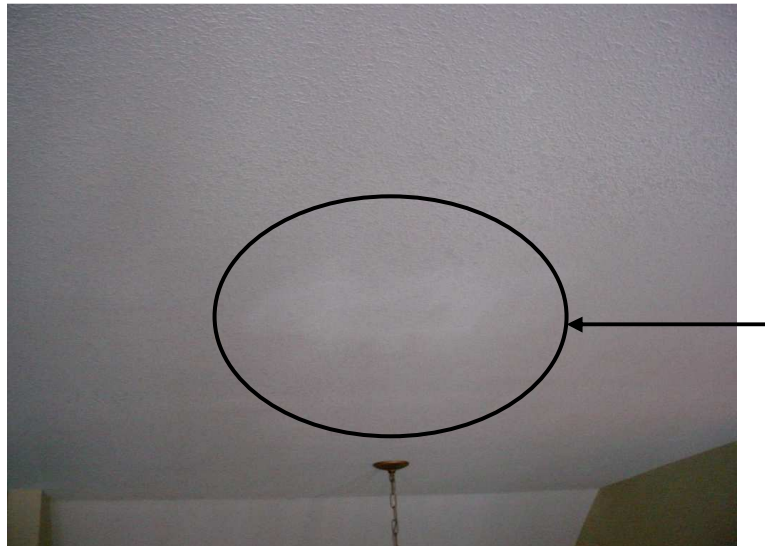
- **Monitor:** Evidence of patching was detected in the upstairs hallway ceiling. No signs of any current/active leakage was present.

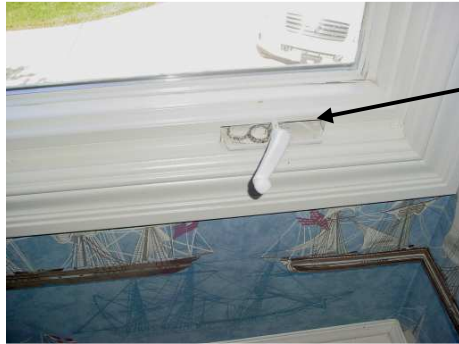
- **Repair:** Windows hardware (cranks) are missing in many locations. The windows were not opened in these locations accordingly.
- **Repair:** Window hardware (crank mechanism) is damaged in the west (blue) bedroom.

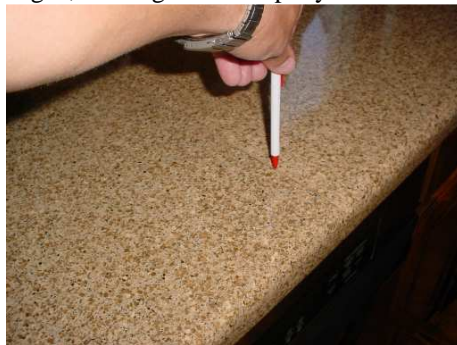
Above the built in oven

- **Repair:** Damaged, missing or loose epoxy at the seams in the granite slabs (countertops) should be improved.
